PRIMARY RECORD

Page 1 of 4 *Resource name(s) or number (assigned by recorder) 3703062, 1075 Market St

Page 4 of 4 *NRHP Status Code 6X
*Resource Name or # (Assigned by recorder) 3703062, 1075 Market St

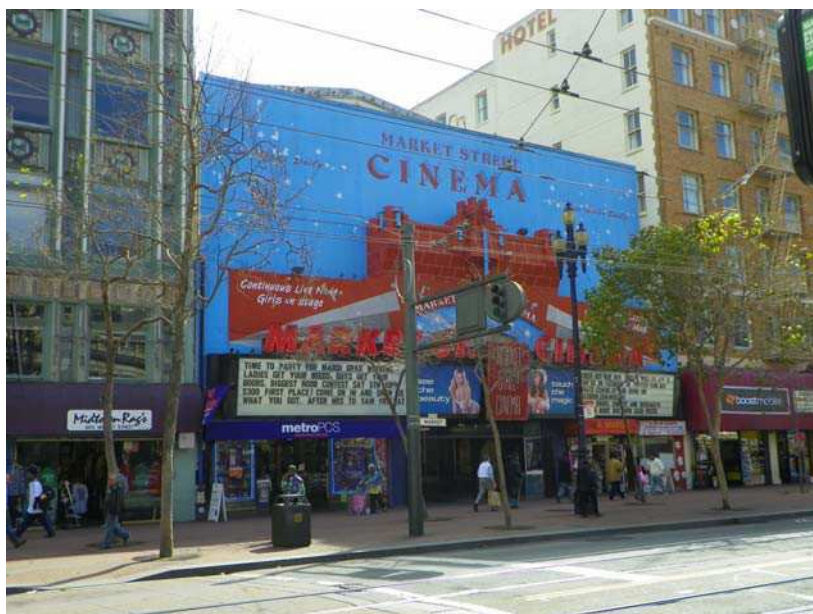
*P5b. Photo (view, date, accession #
View of northwest facade.
103_3827.JPG 3/3/2011

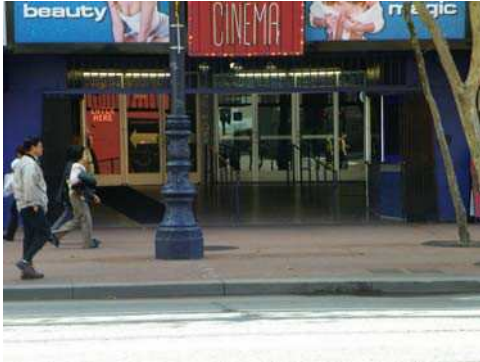
Detail of primary entrance. 103_3830.JPG
3/3/2011

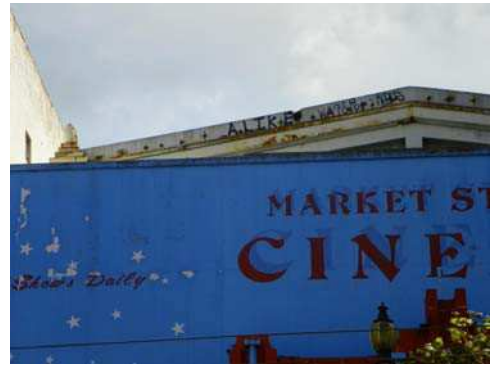
Detail of roofline. 103_3829.JPG 3/3/2011

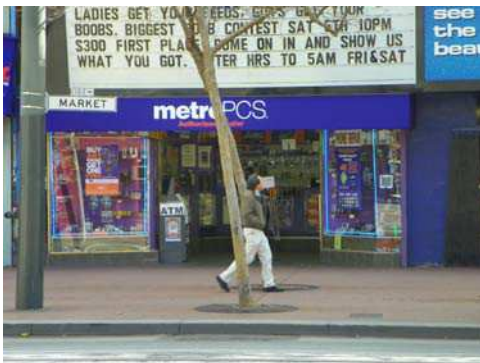
Detail of storefront. 103_3831.JPG 3/3/2011

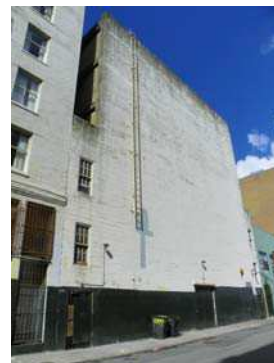
The southeast facade faces Stevenson Street and is clad with unfinished board-form concrete. On the first story level there are three entrances; a set of flush metal double doors at the center and recessed entrances with metal security gates on either side. Above the entrance on the left side are two, six-over-six, double-hung, wood-sash windows at the second and third story levels. Above these windows a narrow section of the facade terminates above the third story. The majority of the facade is featureless and unfenestrated, however, and terminates in a flat unadorned roofline. The secondary facades abut neighboring buildings and are not visible. The building appears to be in fair condition.

View of southeast facade. 103_3849.JPG
3/3/2011
